Standing the test of time

SACRIFICED ON THE PRICE ALTAR

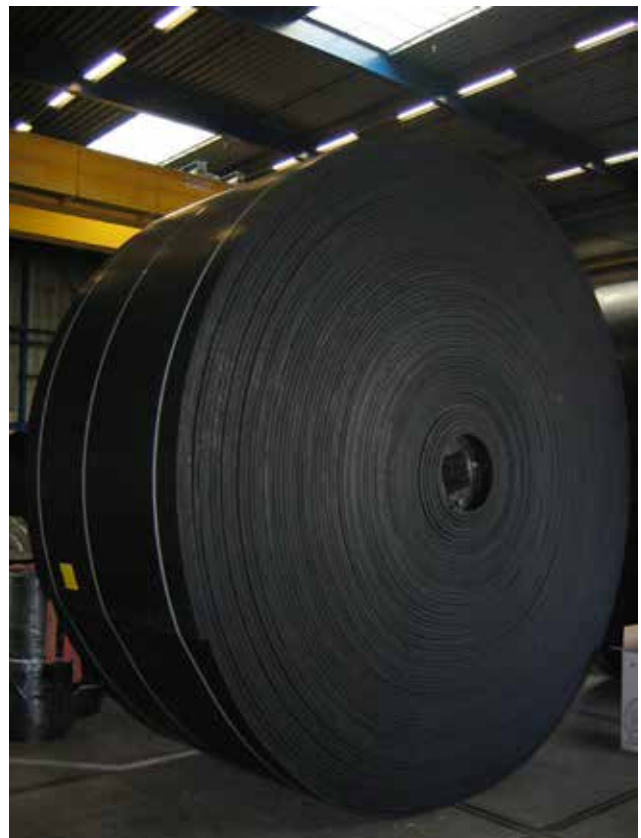
Poor quality belts contain 'timebombs' that quickly start ticking

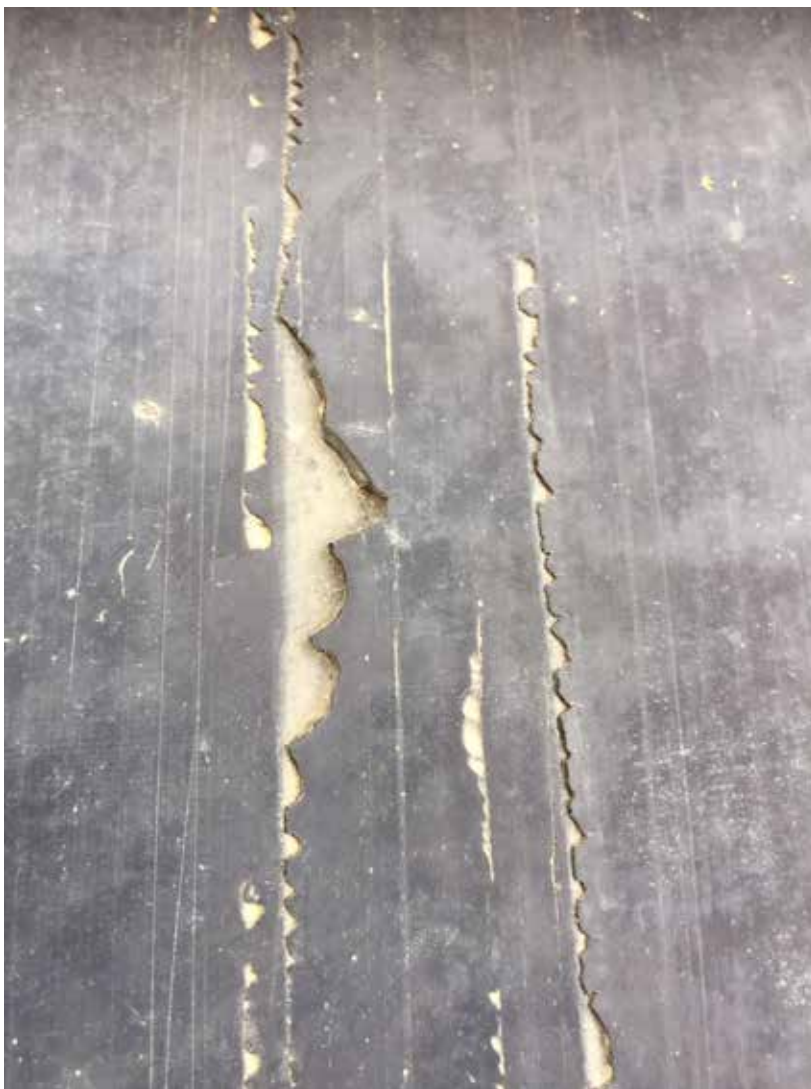
Surface cuts can propagate and link up with other areas of damage, causing pieces of rubber to detach completely if low grade rubber is used.

cover can easily increase in size due to the continuous material loading and the flexing around the drums and pulleys. In time, this spreads and links up with another area of damage causing small pieces of rubber to be cut out from the surface rather than being simply worn thinner.

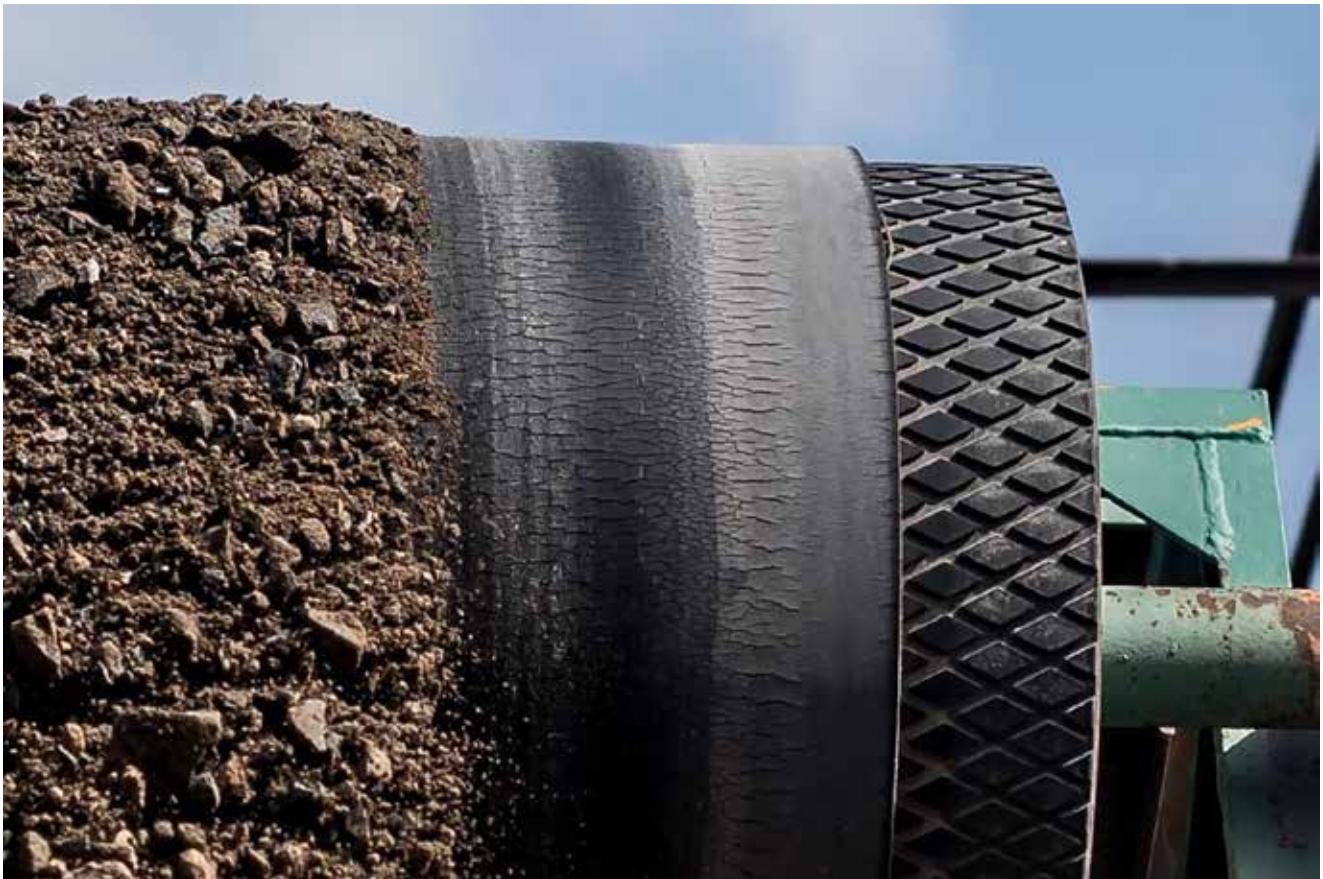
Belts that are not fully resistant to ozone and UV have a much shorter lifespan

ultraviolet light. At ground level, ozone becomes a pollutant that is created by the photolysis of nitrogen dioxide (NO₂) from automobile exhaust and industrial discharges. The reaction, known as ozonolysis, affects the molecular structure of rubber. Exposure, which is unavoidable, increases the acidity of carbon black surfaces and causes reactions within the molecular structure of the rubber. This has several consequences including surface cracking and a marked decrease in the tensile strength, all of which accelerates the wear and general degradation of the rubber.

The first visible sign is cracks in the surface of the rubber. These steadily grow until they complete a 'circuit' and the product separates or fails. Its 'partner in crime' is ultraviolet light from sunlight and fluorescent lighting, which accelerates rubber degradation by producing photochemical reactions that promote the oxidation of the rubber surface resulting in a loss in mechanical strength. Although damage may only start to become visible after a few months, these processes begin as soon as rubber is vulcanized. Prevention is achieved by the inclusion of antioxidants in the rubber compound but the overriding desire to gain a price advantage means that this life-prolonging option is widely ignored, with laboratory testing revealing that up to 90% of belts sold in Europe, Africa and the Middle East do not have such protection.

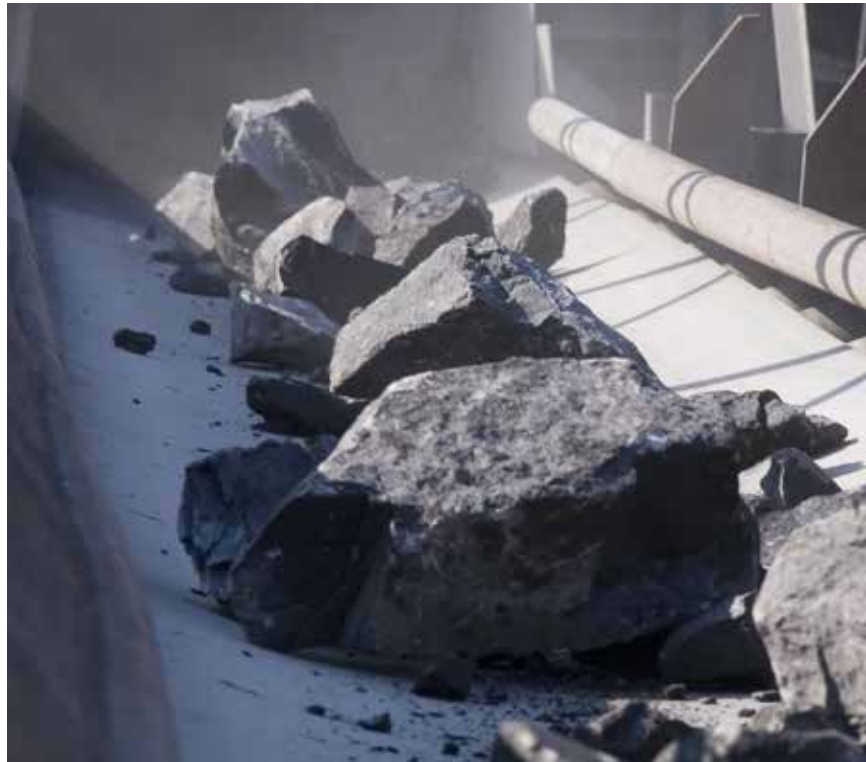
Ripping, tearing and impact – the best solution is to fit a belt specifically engineered for the purpose.

The only genuine solution is to fit a conveyor belt that has been specifically engineered to withstand the kind of punishment that would destroy a normal belt. Despite the higher purchase price, they are also the most cost-effective solution by far. The best examples use uniquely designed fabric plies that allow the nylon weft strands to stretch. As the belt is being pulled through the trapped object, the strands gather into a bundle that eventually becomes strong enough to stop the belt rather than propagate over a much long distance. The design of the fabric weave also allows energy created by heavy impact to be dissipated over a much wider area.

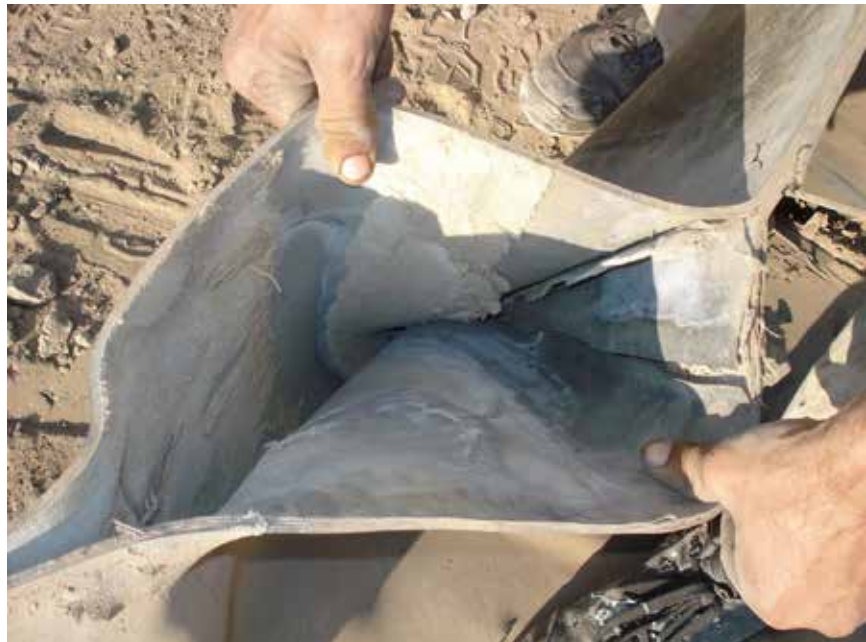
Delamination – layers separate and the belt literally falls apart.

The adhesion properties of a belt are a critical influence on both performance and longevity of any ply construction rubber conveyor belt. The term 'adhesion' relates to the adhesive bond between the inner ply layers to adjoining layers and between the surfaces of the outer plies and the rubber covers. It is defined as the force required to separate (pull apart) the adhesion between adjoining plies and/or between the plies and the outer covers. Good adhesion is fundamental to the durability, functionality and structural integrity of a conveyor belt. Conveyor belts continually flex over pulleys and drums. This repeated action creates stress. It is therefore essential that the belt has adequate ply adhesion to withstand this stress without delaminating, which is where the various layers separate, and the belt literally falls apart.
